MIAMI-DADE COUNTY PERFORMANCE TEST REPORT

Report No.: B6673.01-401-18

PRODUCT TYPE: Exterior Side-Hinged Out-Swing Aluminum Double Door
SERIES/MODEL: MARK Series 381 Dry Glazed (Medium) Double Door

MS381 DRY GLAZE IMPACT DOORS TEST DRAWINGS

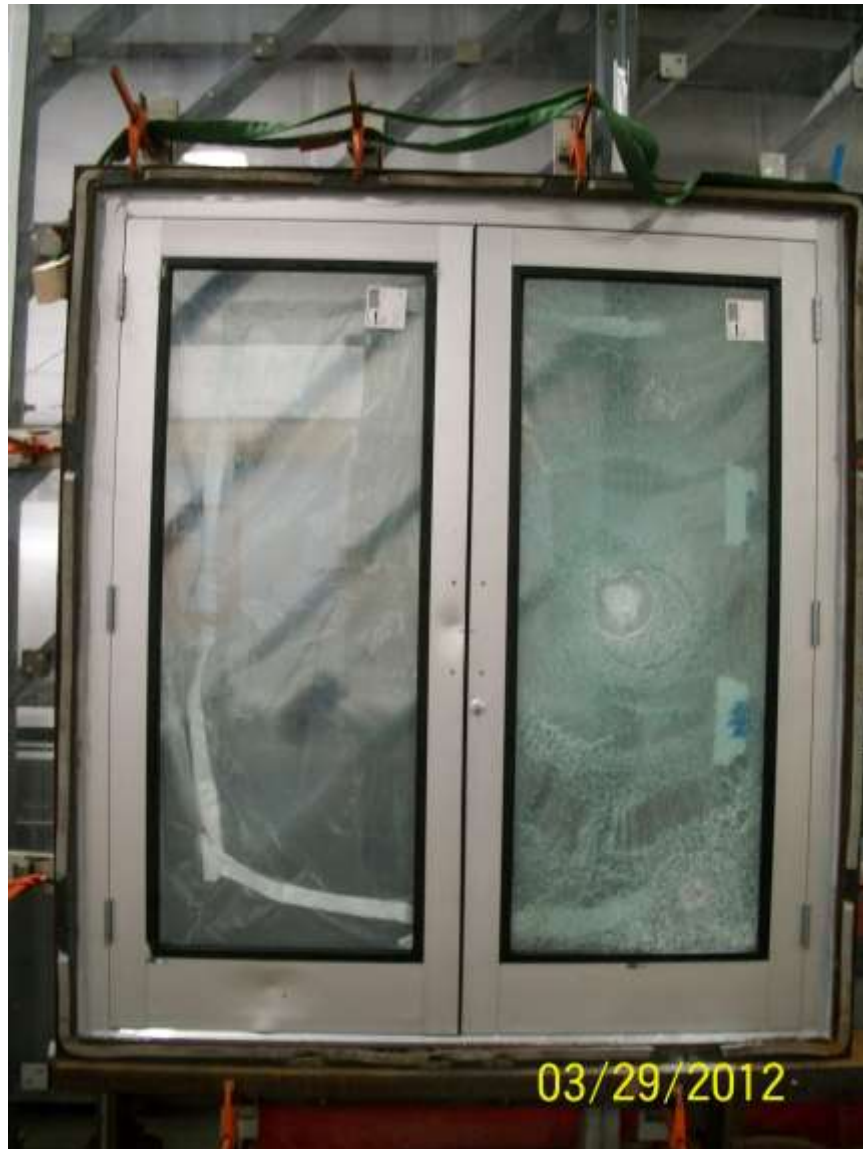
Photo No. 1
MARK Series 381 Dry Glaze (Medium) Double Door

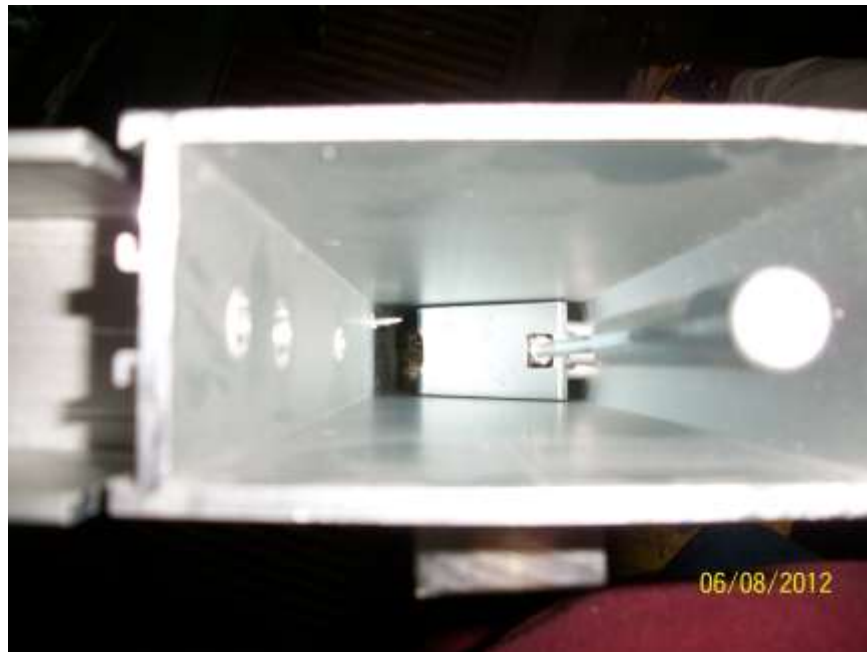
Photo No. 2
Flush Bolt Guide Block Disengaged

Observations: During the 30%-100% negative pressure range; the flush bolt guide became disengaged. (See Photograph #2)
